Re: Progress Report for December 2010

Removal Action, Portland Harbor Superfund Site, NW Natural "Gasco" Facility

Project Number: 000029-02.26

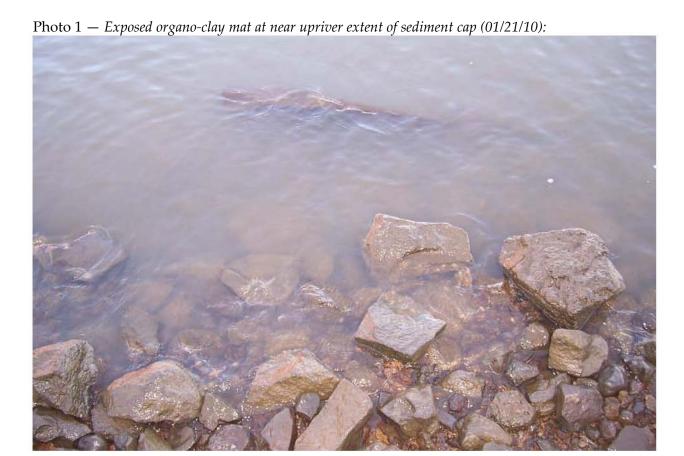
Date January 21, 2010 **Project Number:** 000029-02 BG-21 Task 4 Location: NW Natural "Gasco" Site **Project Name:** NW Natural - Gasco **Monitoring Period:** Monthly(Year 4) – January 2010 Time **Time Observations** Observation Started: January 21, 2010 @ 08:00 Concluded: January 21, 2010 @ 16:00 Weather Partly cloudy, 54 degrees Fahrenheit, 0-7 knot winds from southeast during **Conditions:** pictures **Wave Action Observations:** Light wave action (0.0-0.1 feet in height) **Photographs** No Taken: Yes River level elevation on 01/21/10 ranged from 5.03 to 7.03 **Tidal Conditions:** feet; and approximately 5.63 feet at 14:30 when photos were taken (Datum: Morrison Gage Height) No erosion/deposition is evident along the shoreline. A 2-foot strip of organo-clay mat material was visible beneath the **Observations of Erosion/Deposition:** water surface near the shoreline at the upriver extent of the cap area (Photo 1).

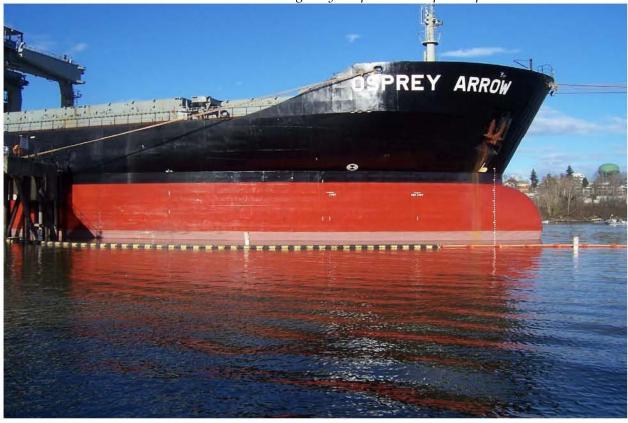
During the Monitoring event, the Fuel and Marine Marketing (FAMM) oil boom was positioned across the cap area, between the upriver corner of the ship dock and the wooden dolphin (near the upriver extent of the site and near the Siltronic Corporation outfall). Buoys that identify the cap area to mariners were in place as installed. The position of the FAMM oil boom, warning buoys and a general overview of the site shoreline are shown in Photo 2.

Photo 2 — FAMM oil boom and mariner warning buoys in place across pilot cap area (01/21/10):

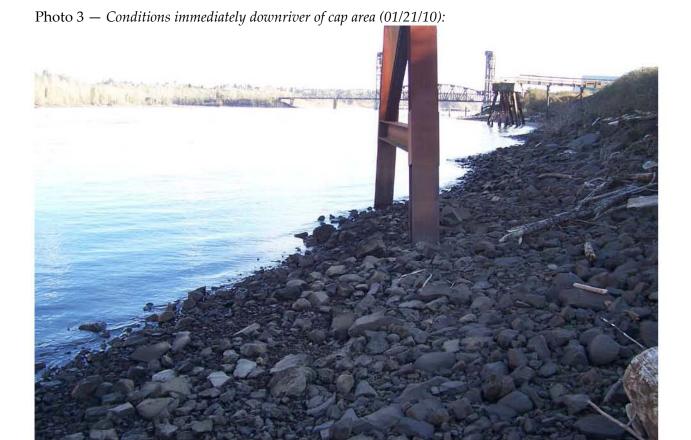
No sheen was observed in or around the cap area. Photo 3 shows the water surface and shoreline immediately downriver of the sediment cap. A ship (the Osprey Arrow) was docked along at the FAMM pier.

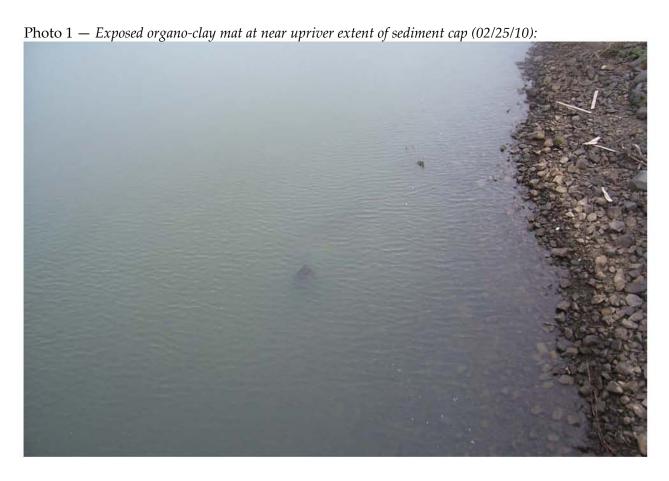
**Date Project Number:** February 25, 2010 000029-02 BG-21 Task 4 Location: NW Natural "Gasco" Site **Project Name:** NW Natural - Gasco **Monitoring Period:** Monthly(Year 4) - February 2010 Time Observation **Time Observations** Started: February 25, 2010 @ 14:00 Concluded: February 25, 2010 @ 15:30 Weather **Conditions:** Cloudy, 52-57 degrees Fahrenheit, 0-3 knot winds from northwest **Wave Action Observations:** Light wave action (0.0-0.3 feet in height) **Photographs** No Taken: Yes Willamette River level on 02/25/10 ranged from 2.56 to 5.99 feet. The Willamette River level during photos is **Tidal Conditions:** approximately 5.88 feet at 14:45 (River Level Datum: Morrison Gage Height) No erosion/deposition is evident along the shoreline. Three segments of organo-clay mat material are visible beneath **Observations of Erosion/Deposition:** the water surface, one near the shoreline at the upriver extent of the cap area and the other two approximately 20 feet off the shoreline. (Photo 1).

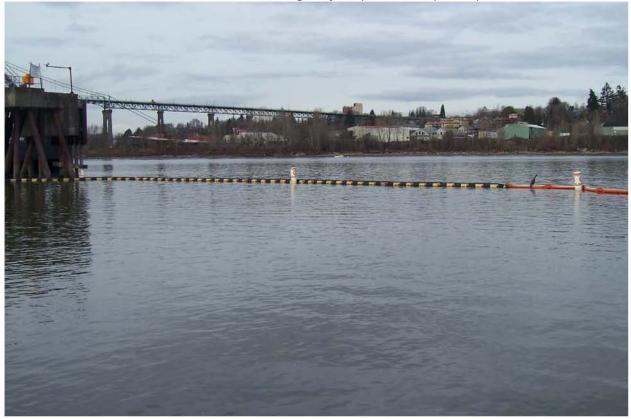
The Fuel and Marine Marketing (FAMM) containment boom is positioned across the cap area, between the upriver corner of the ship dock and the wooden dolphin (near the upriver extent of the site and near the Siltronic Corporation outfall). Buoys that identify the cap area to mariners are in place as installed. The position of the FAMM oil boom, warning buoys and a general overview of the site shoreline are shown in Photo 2.

Photo 2 - FAMM oil boom and mariner warning buoys in place across pilot cap area (02/25/10):

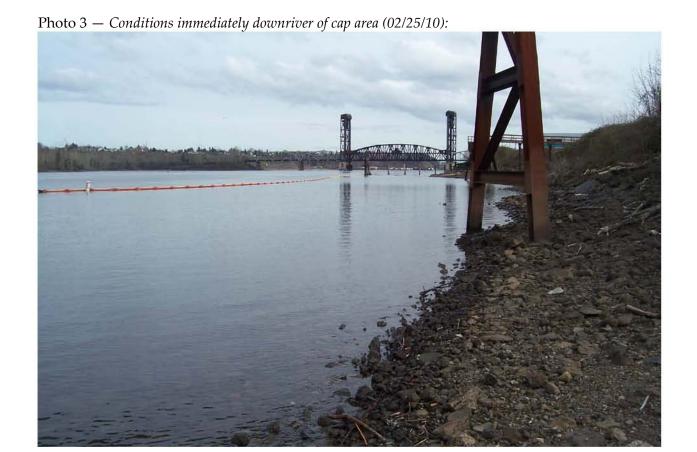
No sheen is evident in or around the cap area. Photo 3 shows the water surface and shoreline immediately downriver of the sediment cap. A barge is docked at the riverward face of the FAMM pier.

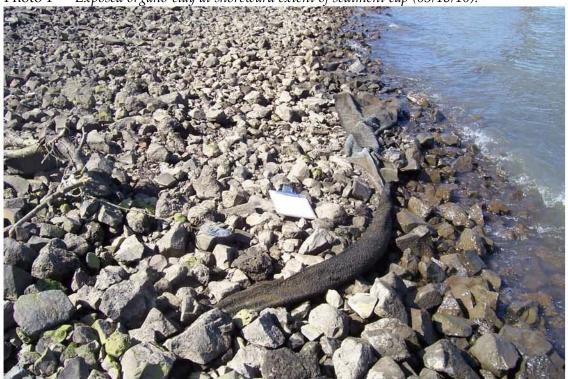
No erosion/deposition is evident along the shoreline. Three **Observations of Erosion/Deposition:**

segments of organo-clay mat material are visible beneath

the water surface. (Photo 1).

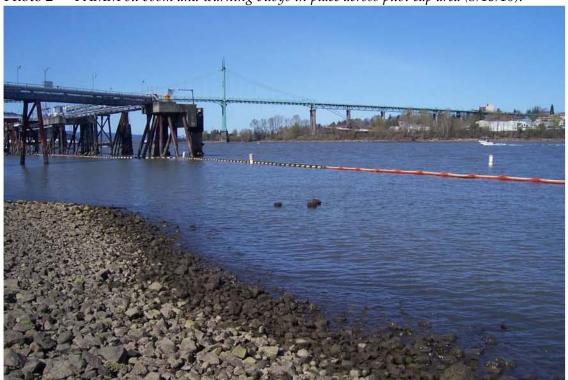
The Fuel and Marine Marketing (FAMM) containment boom is positioned across the cap area between the upriver corner of the ship dock and the wooden dolphin (near the upriver extent of the site and near the Siltronic Corporation outfall). Buoys that identify the cap area to mariners are in place as installed. The position of the FAMM oil boom, warning buoys and a general overview of the site shoreline are

Photo 2 — FAMM oil boom and warning buoys in place across pilot cap area (3/18/10):

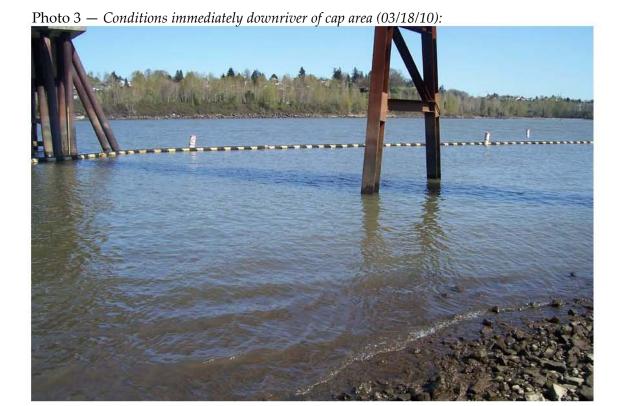
No sheen is evident in or around the cap vicinity. Photo 3 shows the water surface and shoreline immediately downriver of the sediment cap.

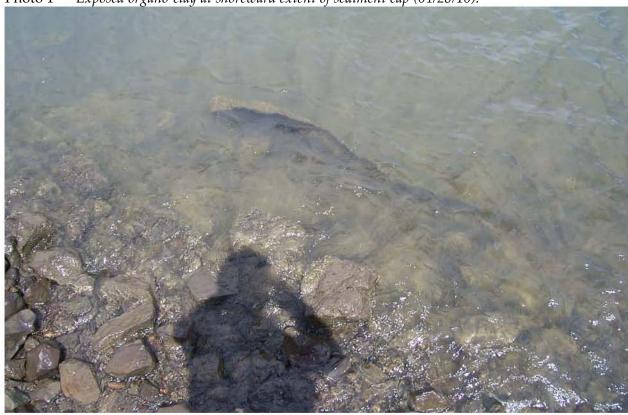
No erosion/deposition is evident along the shoreline of the **Observations of Erosion/Deposition:**

capped area. Two segments of organo-clay mat material are

visible beneath the water surface (Photo 1).

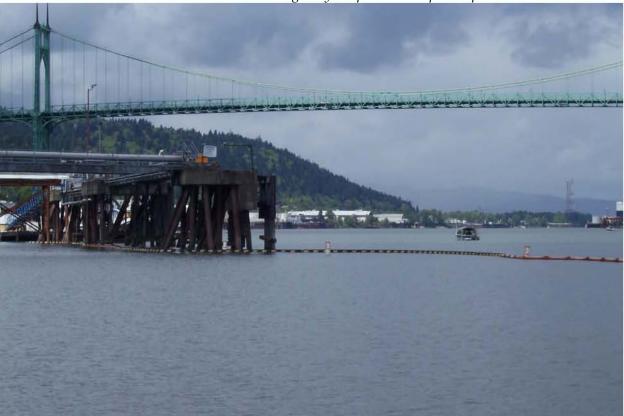
The Fuel and Marine Marketing (FAMM) containment boom is positioned across the cap area between the upriver corner of the ship dock and the wooden dolphin (near the upriver extent of the site and near the Siltronic Corporation outfall). Buoys that identify the cap area to mariners are in place as installed. The position of the FAMM oil boom, warning buoys and a general overview of the site shoreline are

Photo 2 — FAMM oil boom and mariner warning buoys in place across pilot cap area (04/28/10):

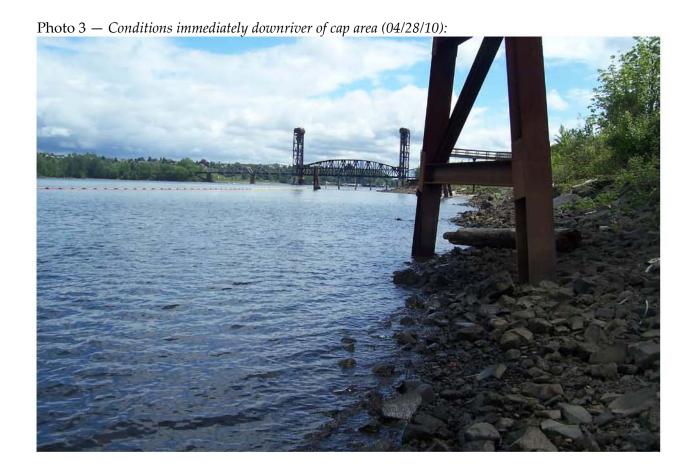
No sheen is evident in or around the cap vicinity. Photo 3 shows the water surface and shoreline immediately downriver of the sediment cap.

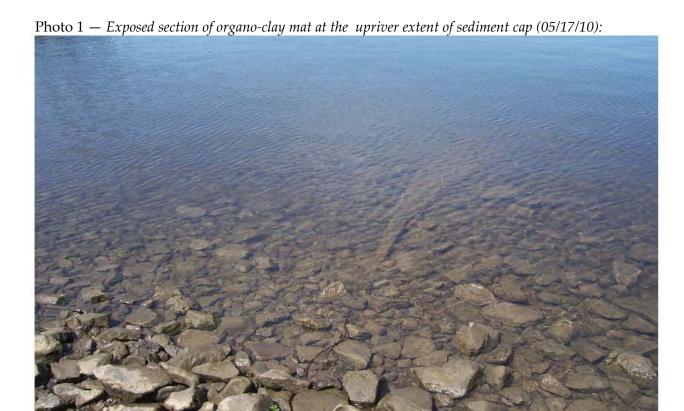
No erosion/deposition is evident along the shoreline. Three

sections of organo-clay mat material are visible beneath the water surface. One exposed section of organo-clay mat is visible at the upriver extent of the cap area extending from 2 feet to 10 feet channelward of the water's edge. Two exposed sections of exposed organo-clay mat are visible

approximately 1-2 feet channelward of the water's edge, one near the midpoint of the cap area and the second near its

downriver extent. (Photo 1).

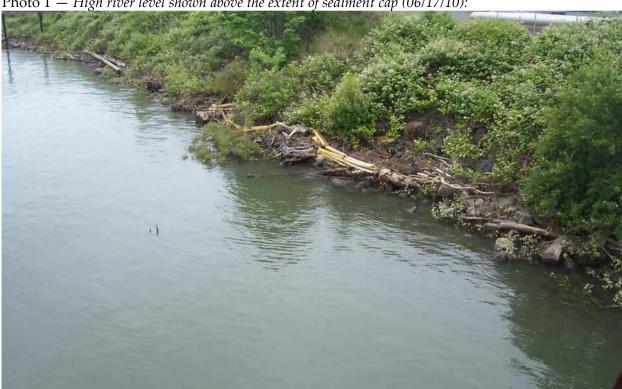
Photo 1 - High river level shown above the extent of sediment cap (06/17/10):

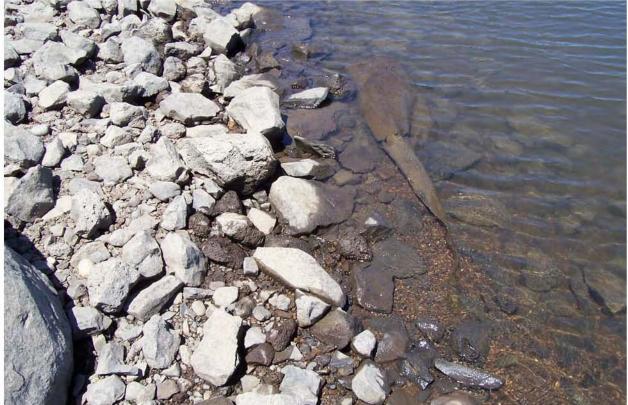
No erosion/deposition is evident along the shoreline. Three

sections of organo-clay mat material are visible beneath the water surface. One exposed section of organo-clay mat is visible at the upriver extent of the cap area extending from 2 feet to 10 feet channelward of the water's edge. Two exposed sections of exposed organo-clay mat are visible

approximately 1-2 feet channelward of the water's edge, one near the midpoint of the cap area and the second near its

downriver extent. (Photo 1).

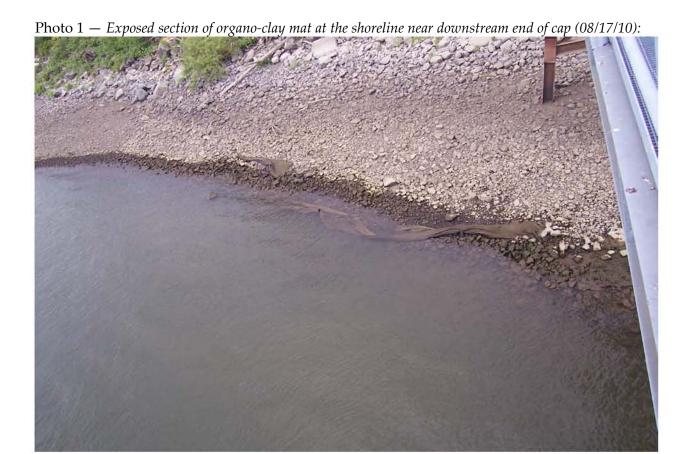
No erosion/deposition is evident along the shoreline. Three

sections of organo-clay mat material are on the beach along the shoreline. One exposed section of organo-clay mat is visible at the upriver extent of the cap area extending from the river's shoreline to 10 feet out of the water. Two exposed sections of exposed organo-clay mat are visible

near the midpoint of the cap area, one 3 foot in length, the other about 18 inches. The last exposed mat is near the downriver side, along the shoreline, approximately 30 feet

long. (Photo 1).

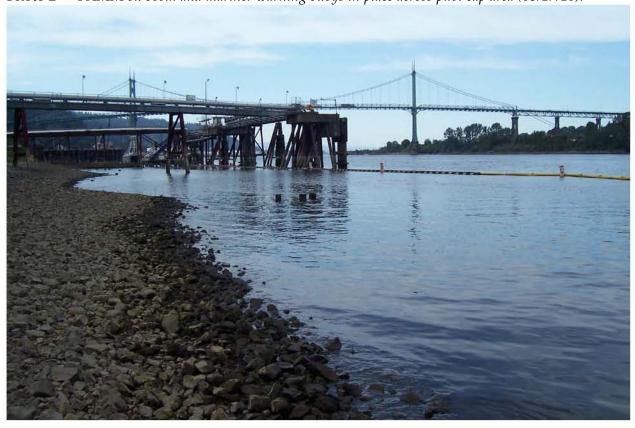
The Fuel and Marine Marketing (FAMM) containment boom is positioned across the cap area, between the upriver corner of the ship dock and the wooden dolphin (near the upriver extent of the site and near the Siltronic Corporation outfall). Buoys that identify the cap area to mariners are in place as installed. The position of the FAMM oil boom, warning buoys and a general overview of the site shoreline

Photo 2 — FAMM oil boom and mariner warning buoys in place across pilot cap area (08/17/10):

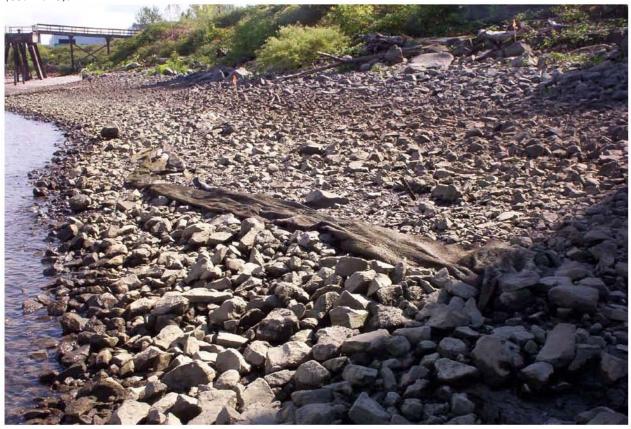
No erosion/deposition is evident along the shoreline. All

visible organo-clay mat material segments are out of the water. One exposed section of organo-clay mat is visible at the upriver extent of the cap area is approximately 15 feet long and 2 feet from the water's edge. Two exposed

sections of exposed organo-clay mat are visible near the midpoint, head of the cap area, one 4 foot in length, the other about 2 feet. The last exposed mat is near the downriver side, 4 feet from the shoreline, approximately 30

feet long. (Photo 1).

Photo 1-Exposed section of organo-clay mat 4 feet from the shoreline near downriver end of cap (09/21/10):

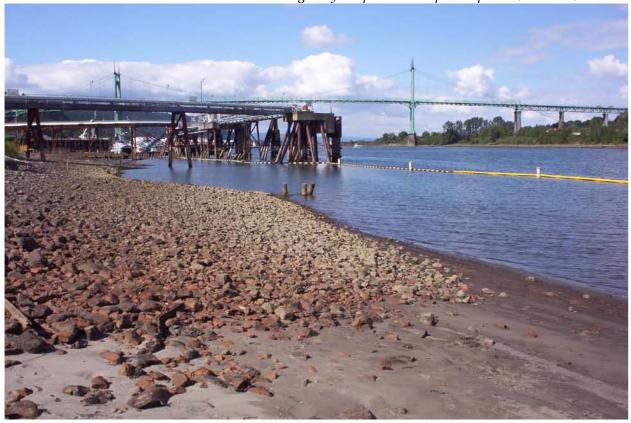
The Fuel and Marine Marketing (FAMM) containment boom is positioned across the cap area, between the upriver corner of the ship dock and the wooden dolphin (near the upriver extent of the site and near the Siltronic Corporation outfall). Buoys that identify the cap area to mariners are in place as installed. The position of the FAMM oil boom, warning buoys and a general overview of the site shoreline

Photo 2 — FAMM oil boom and mariner-warning buoys in place across pilot cap area (09/21/10):

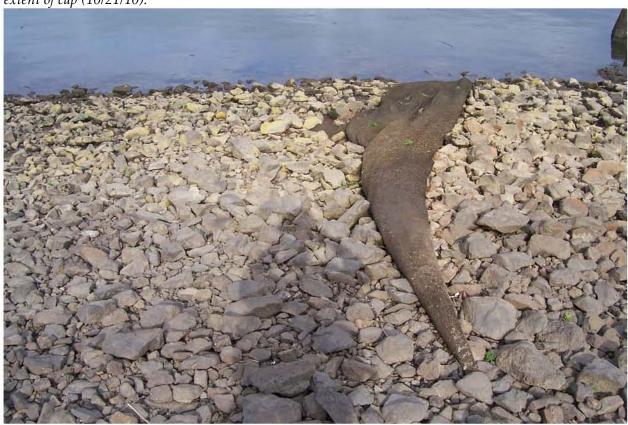
No erosion/deposition is evident along the shoreline. All

visible organo-clay mat material segments are out of the water. One exposed section of organo-clay mat is visible at the upriver extent of the cap area is approximately 15 feet long and 2 at the water's edge. Two exposed sections of exposed organo-clay mat are visible near the midpoint, head of the cap area, one 4 foot in length, the other about 2 feet.

The last exposed mat is near the downriver side, 4 feet from

the shoreline, approximately 30 feet long. (Photo 1).

Photo 1-Exposed section of organo-clay mat 15 feet long extends to the river's edge at the upriver extent of cap (10/21/10):

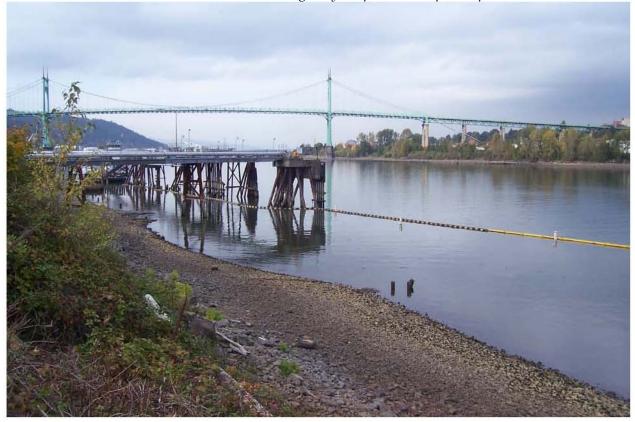
The Fuel and Marine Marketing (FAMM) containment boom is positioned across the cap area, between the upriver corner of the ship dock and the wooden dolphin (near the upriver extent of the site and near the Siltronic Corporation outfall). Buoys that identify the cap area to mariners are in place as installed. The position of the FAMM oil boom, warning buoys and a general overview of the site shoreline

Photo 2 - FAMM oil boom and mariner warning buoys in place across pilot cap area (10/21/10):

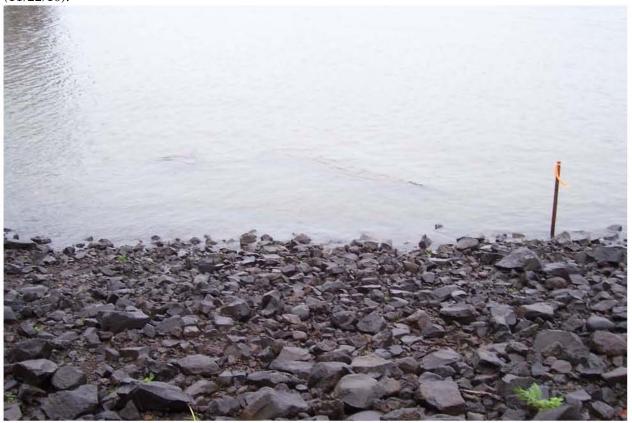
No erosion/deposition is evident along the shoreline. The

visible organo-clay mat segments are partially submerged. Approximately 3 feet of organo-clay mat is visible at the upriver extent of the cap. One exposed section of exposed organo-clay mat measuring 4 foot in length is visible approximately 2 feet from the river's edge. The last exposed

organoclay mat is approximately 20 feet long located near

the downriver extent of the cap, and submerged in

approximately1.5 feet of water,. (Photo 1).

Photo 1-V is ible section of organo-clay mat 20 feet long in 1.5 feet of water on the downriver end of cap (11/22/10):

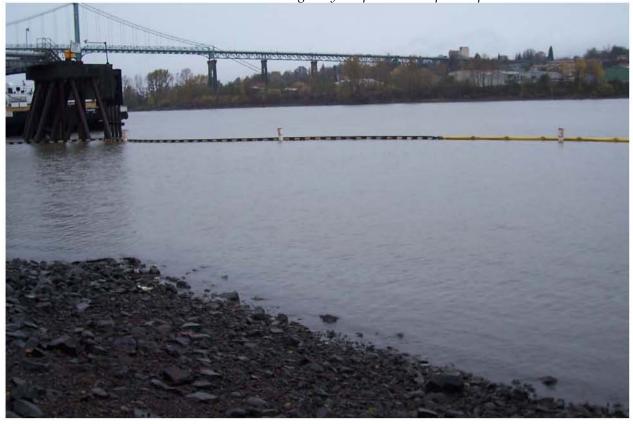
The Fuel and Marine Marketing (FAMM) containment boom is positioned across the cap area, between the upriver corner of the ship dock and the wooden dolphin (near the upriver extent of the site and near the Siltronic Corporation outfall). Buoys that identify the cap area to mariners are in place as installed. The position of the FAMM oil boom, warning buoys and a general overview of the site shoreline is shown in Photo 2.

Photo 2 - FAMM oil boom and mariner warning buoys in place across pilot cap area (11/22/10):

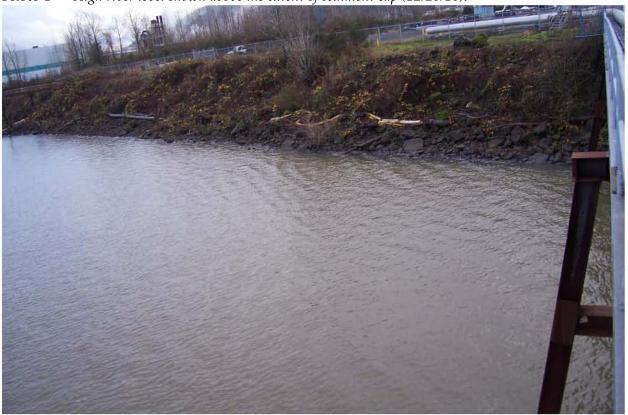
No erosion/deposition is evident along the shoreline. Due to

high river water levels, the exposed organo- clay mat material observed in preceding events was not visible

(Photo 1).

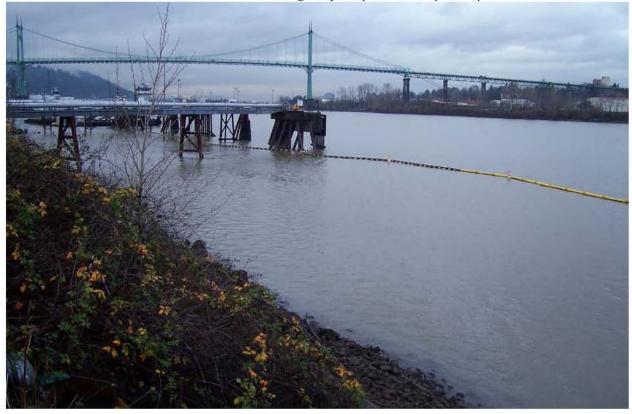
The Fuel and Marine Marketing (FAMM) containment boom is positioned across the cap area, between the upriver corner of the ship dock and the wooden dolphin (near the upriver extent of the site and near the Siltronic Corporation outfall). Buoys that identify the cap area to mariners are in place as installed. The position of the FAMM oil boom, warning buoys and a general overview of the site shoreline

Photo 2 — FAMM oil boom and mariner warning buoys in place across pilot cap area (12/20/10):
